PROPERTY INSPECTION REPORT

Concerning: 12345 Someplace Street, Central, Texas
(Address or Other Identification of Inspected Property)

By: David Crist TREC Lic 5826 10/4/2006
(Name and License Number of Inspector) (Date)

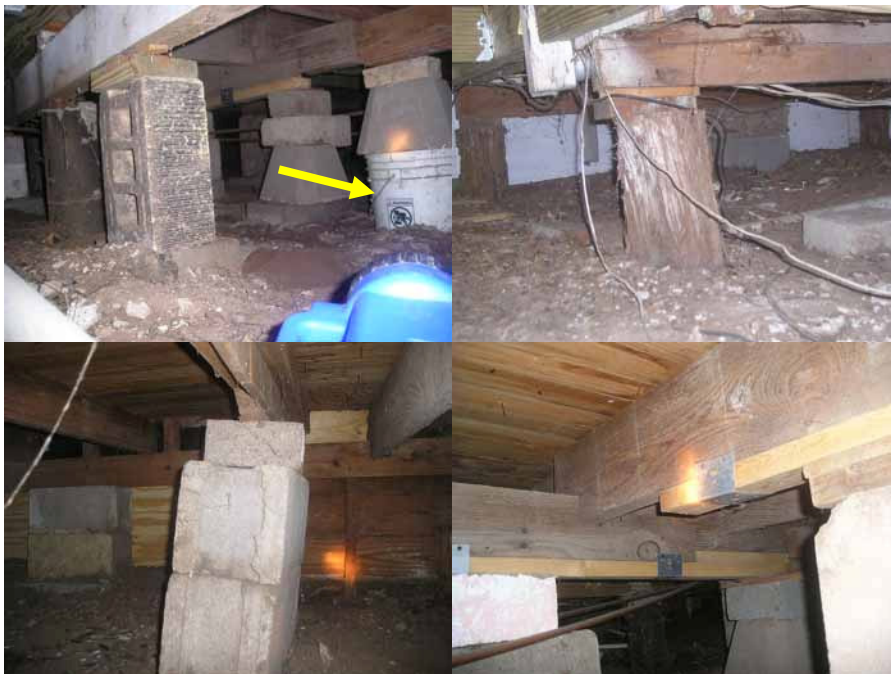
The foundation is not performing as intended. See additional comments below.

- Cracks were observed on exterior walls of the house.
- Cracks were observed on the interior walls/ceilings of the house.
- Doorframes were found to be out-of-square within house.
- Sloping floors were observed within house.
- Footings for the Piers are improper.
- Piers are leaning.

The foundation is a mixture of materials, made up of original cedar posts, cinder blocks, plastic buckets and numerous inadequate repairs. **The foundation is in need of major repair. A structural engineer and or a qualified foundation contractor should be consulted to further evaluate this condition and possible remedies available for correction.**

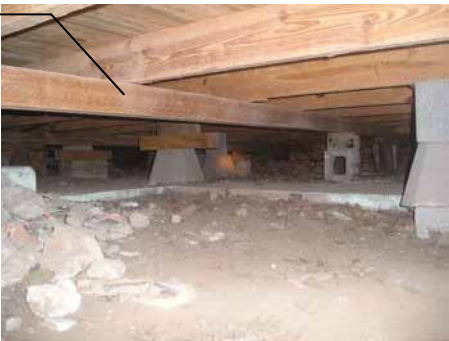
Most of the Girders (main beams that support floor joist) are improperly sized and piers are spaced to fare apart to properly support floor joist.

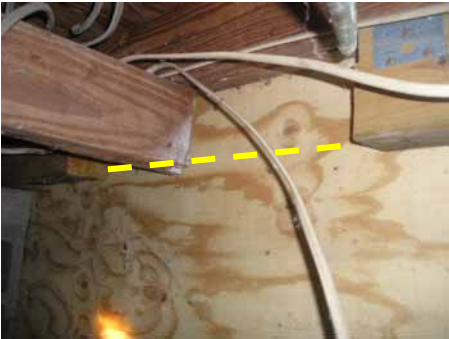
A section of the perimeter girder (generally below the kitchen sink) is missing. Floor joist are not properly supported in this location.

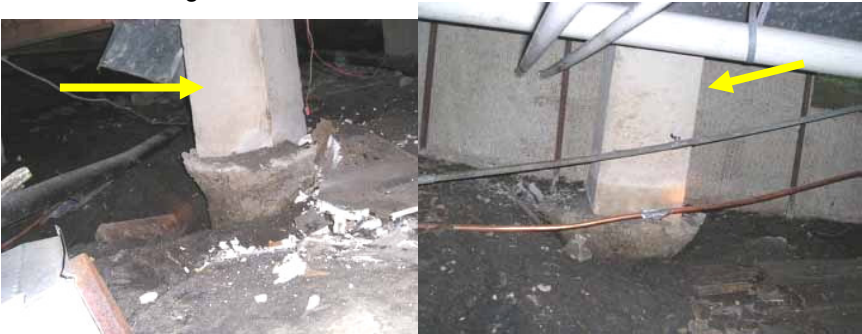
Soil has eroded away from the base of some of the piers at the left rear corner of the crawl space. This should be repaired to prevent the piers from moving and causing structural damage.

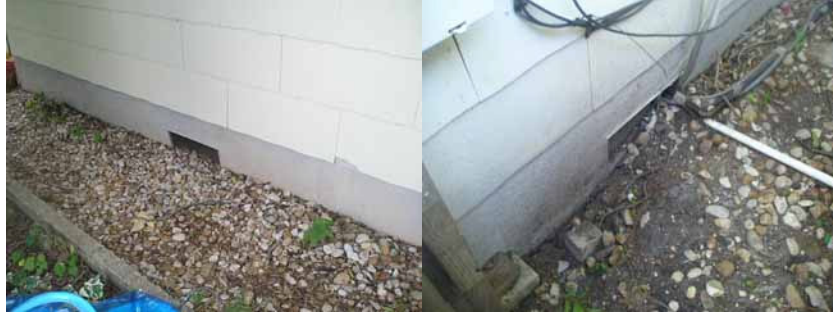
The grade of the ground around the front house should be improved to promote the flow of storm water away from the house. This can usually be accomplished by the addition or removal of top soil. The ground should slope away from the house at a rate of one inch per foot for at least the first ten feet.

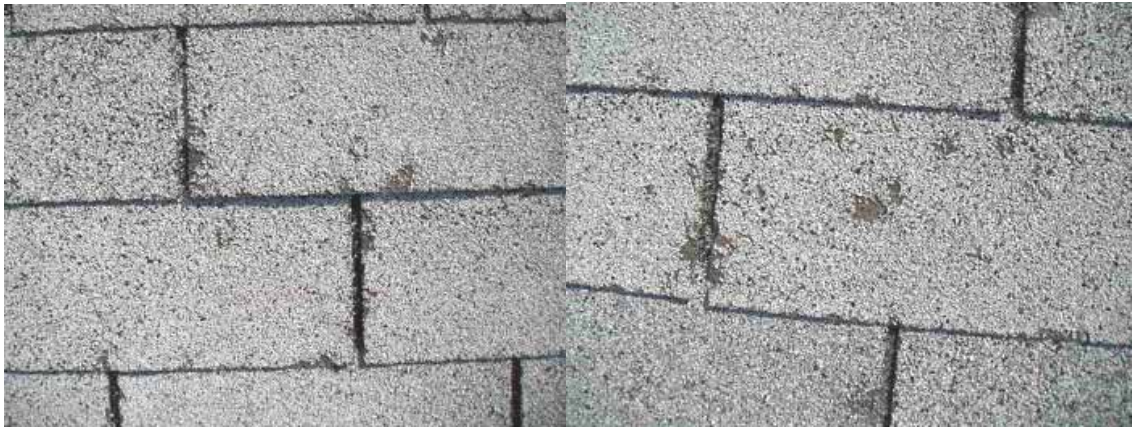
There is evidence of severe hail damage. **Further evaluation should be made by a roofing specialist and/or insurance company to determine its effective life and insurability.**

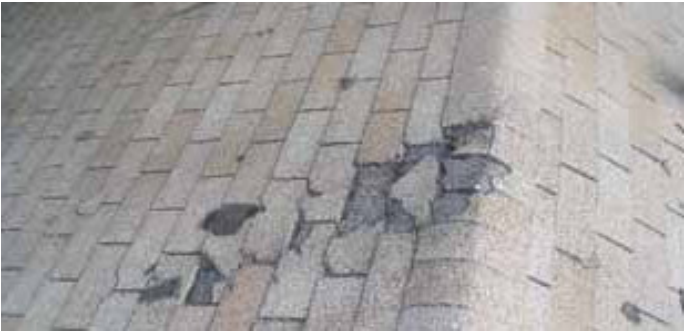
Damaged or missing roofing material at the center of the roof should be repaired. All roof penetrations should be examined and sealed as necessary.

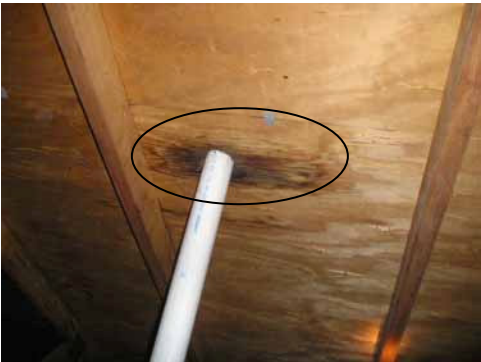
Evidence of roof leakage was observed in the attic. **A qualified roofing contractor should evaluate the entire system before the end of your option period and or the purchase of the house.**

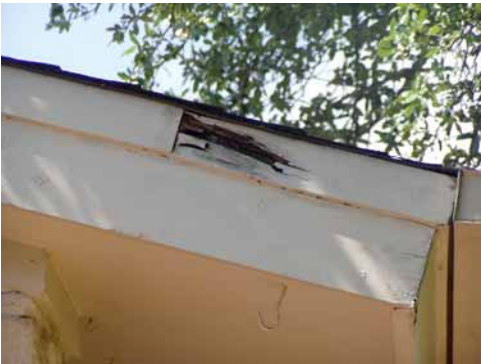
Fascia boards are damage at the front left corner of the house.

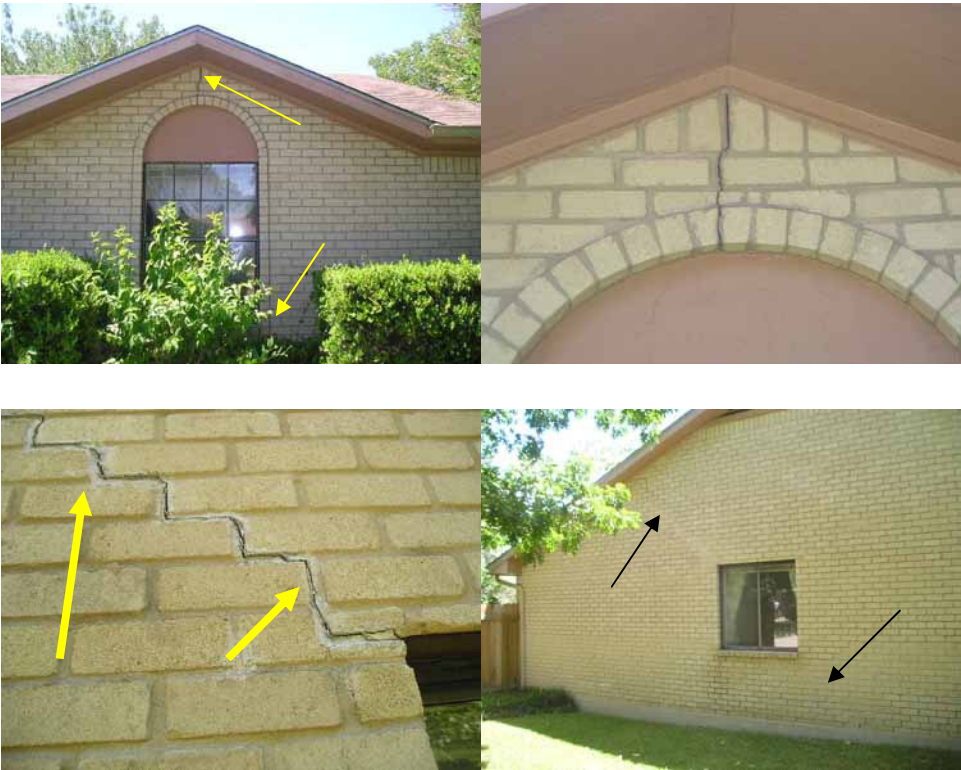
Comments:
Larger than typical cracks were noted on exterior brick veneer walls. This condition could indicate greater than normal movement within the structure and potential structural problems. Further investigation may be necessary.

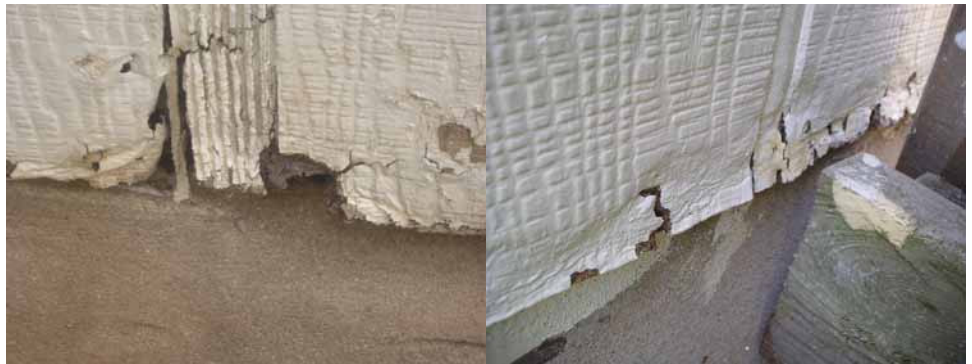
Water damage was noted on the exterior trim boards and siding at along the back wall of the house. The extent of damage to the area behind this area could not be determined. Prolong exposure to moisture can cause damage to areas not visible. Repairs should be undertaken to prevent further damage to the structure.

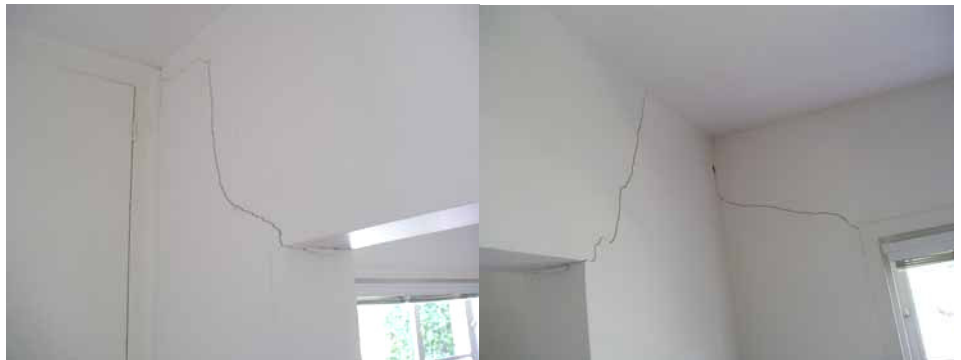
Cracks were observed on the interior walls and ceilings of the house. This implies that some structural movement of the building has occurred, as is typical of most houses. See foundation above.

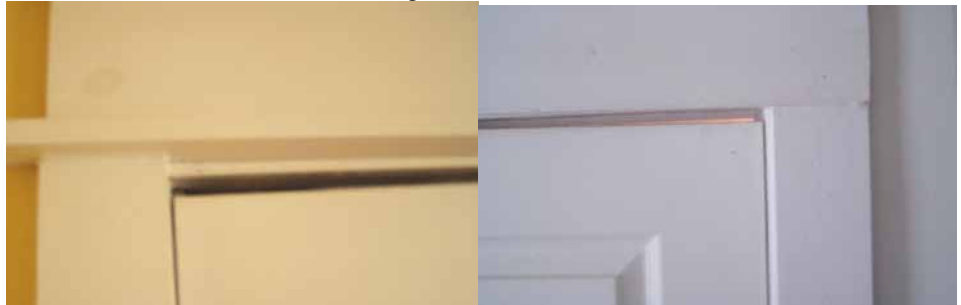
Doors in various location are not square in there frames. This implies that some structural movement of the building has occurred. See foundation above.

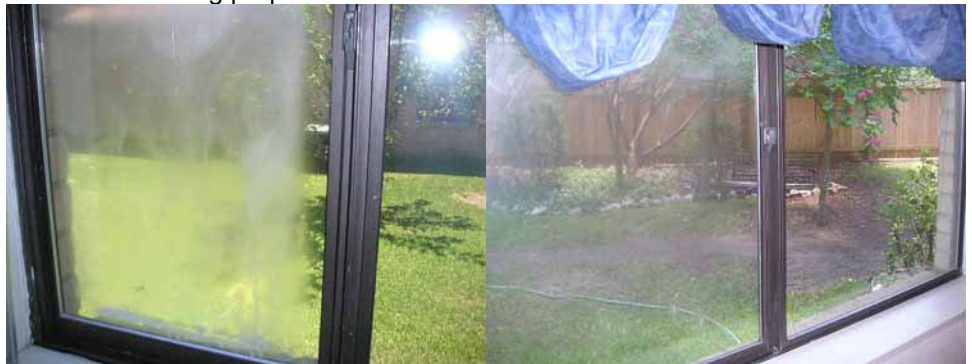
Windows in the master bedroom have lost their seal (fogged). This has resulted in condensation developing between the panes of glass and can cause the glass to loose its insulating properties.

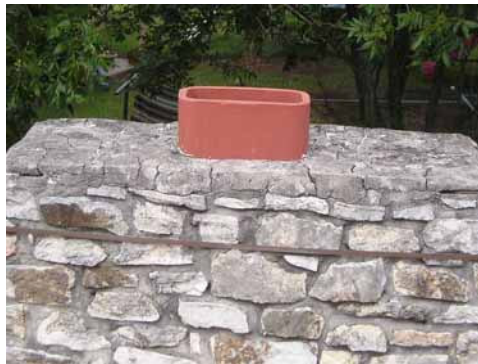
Significant creosote build up was noted in the fireplace flue and/or firebox. Cleaning of these areas should be undertaken for improved safety.

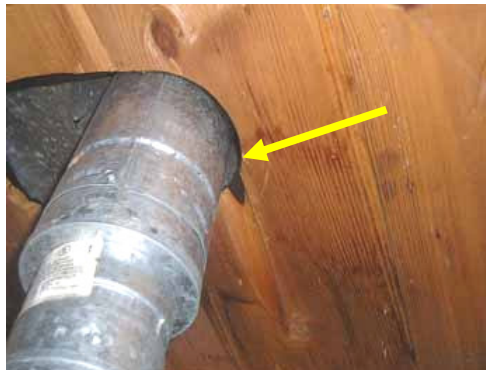
There is insufficient clearance between the exhaust flue and combustible materials. *This is a fire hazard.* This condition should be evaluated and repaired by a qualified licensed heating technician.

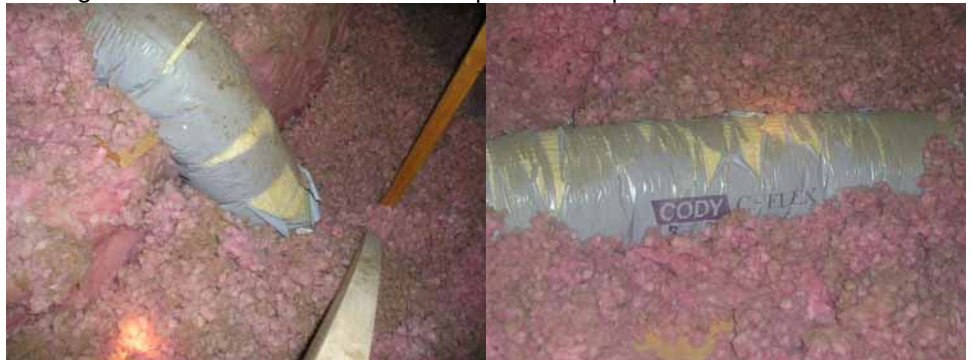
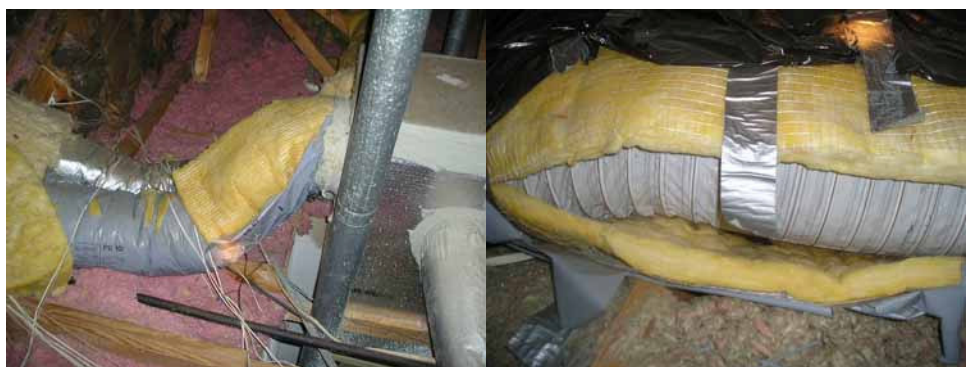
The ductwork is covered in gray plastic. This plastic is known to deteriorate over time. Replacement will become necessary in the future.

Damaged ducts in the attic should be repaired or replaced.

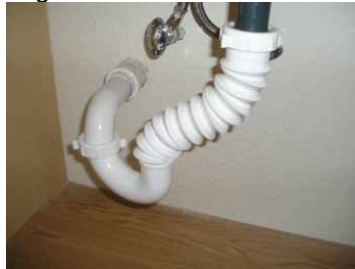
Improper drainpipe with ridges attached to the bathroom sink should be replaced. The ridges tend to catch items and cause the pipe to clog.

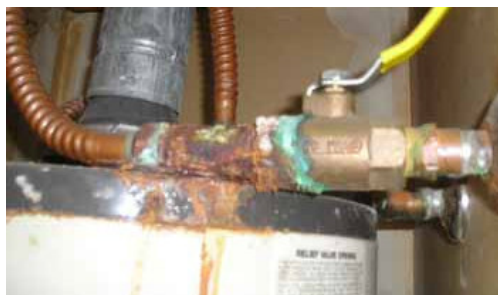
The water supply piping is leaking where it meets the water heater. Water is likely leaking (or will) at these locations. Repairs are needed to prevent damage. The installation of brass pipefitting where the water pipes meet the unit is recommended.
